Conveyance and Drainage System in Spate Irrigation -A case of Boro Dodota Spate Irrigation-

Yohannes GELETA¹, Chali EDESSA¹, Kozo INADA², Yoshiaki OTSUBO²,
Shinji SUZUKI³, Hiromichi TOYODA³

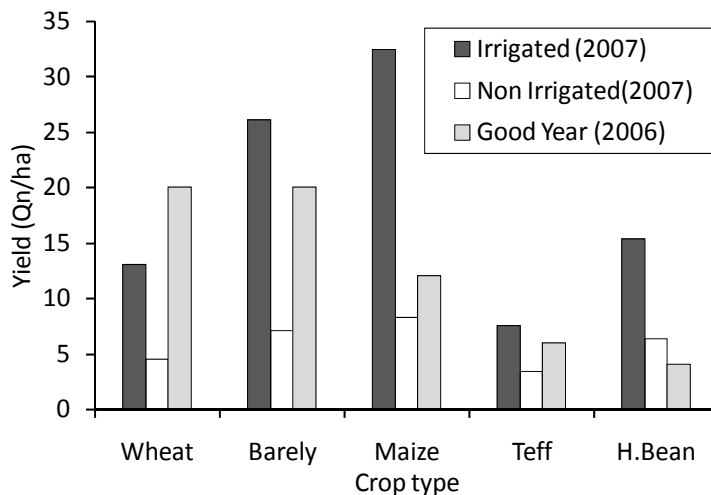
Fig. 1. The effect of spate irrigation on crop production. (After Kebebew *et al.*, 2008)

In order to investigate the impact of the project on crop production, the Irrigation Farming Improvement (IFI) organized by Japan International Cooperation Agency (JICA) and Oromia Water Resource Bureau (OWRB) undertook field visit and data collection in 2007. Out of the command area 280 ha of the land was subjected to the analysis. It is revealed that the production with spate irrigation was significantly higher than that with non-irrigated condition, and it was comparable to the yield record in 2006 which had sufficient rain (Fig. 1, Kebebew *et al.*, 2008).

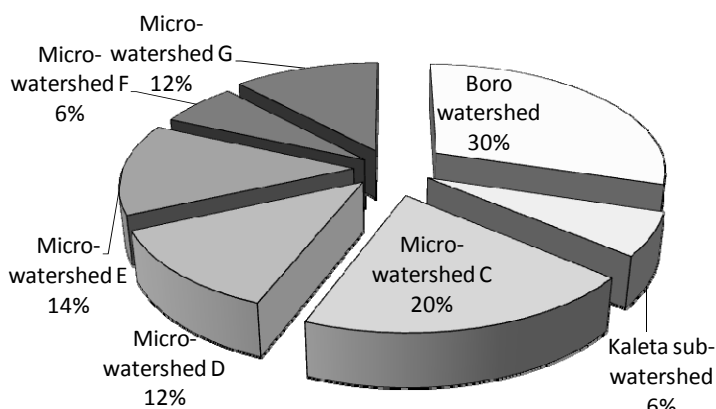
Fig. 2. Component of watershed of the Boro dodota spate irrigation.

To scale up the previous verification result to all over the project command area, constraints were also observed. The project encounters eleven natural drainages which collect flood from the sub and micro watershed, out of which five of them had severe impact on the main canal, the command area, and the drainage system. The micro catchment area of these eleven natural drainages covers 163 km² area which is greater than that of Boro watershed, 69.3 km² retrieved by Arc GIS (Fig. 2).

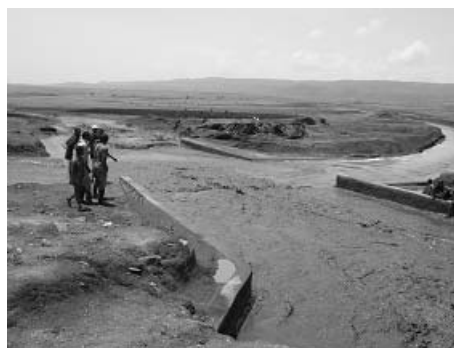
Fig. 3. Flood over the hydraulically regulated structure.

Assuming the same land use and rainfall for the main river catchment and sub and micro watershed of the command area, one would judge that the flood yield from sub and micro watershed could have not only positive impact but also considerable negative impact when treated inadequately. During the past two years, flood from these micro catchments brought significant damage on farming areas and some residences (Fig. 3).

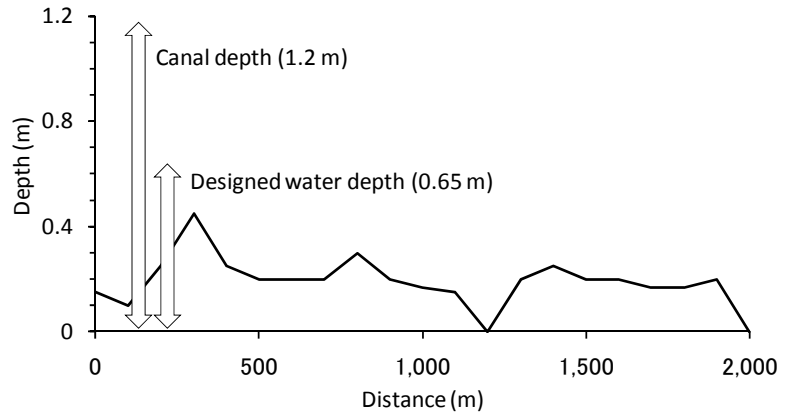
Fig. 4. Silt sedimentation in the main canal.

The main canal was designed and constructed to take $6 \text{ m}^3/\text{sec}$ of flood from the wadi or the micro catchments and to spill the excess water at 6 different hydraulically regulated crossing structures to the natural drain. However, due to high silt content of the flood, especially from the watershed, the capacity of the canal decreased resulting in overtopping from the main canal at different places. Further, structures were filled with silt (Fig. 4).

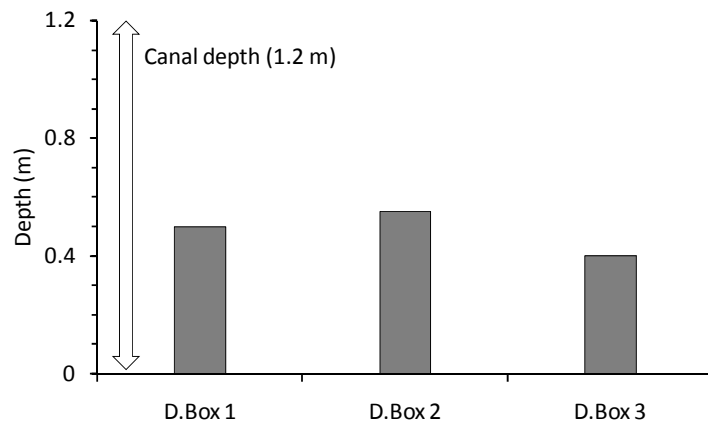
Fig. 5. Silt sedimentation in the division boxes.

Silt sediment was observed for the lined main canal and division box structures ranging from 20 to 40% and from 30 to 45%, respectively (Fig. 5). The earthen main canal had also silt sediment up to 60% of their capacity with single rainy season flood event (Fig. 6).

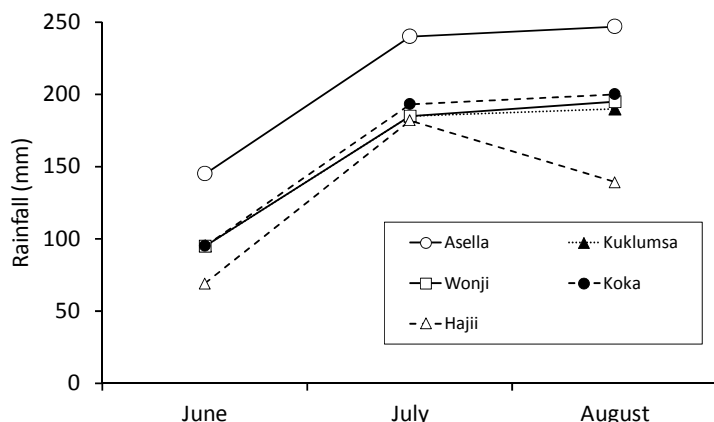
Fig. 7. Rainfall data observed at a meteorological station and FAO retrieved data.

Meteorology, watershed and soil data are essential for sustainable and efficient project. The project was designed using FAO retrieved data at Asella meteorological station, 30 km apart from the head work to the south. The head work and the command area are located between 1,500 and 1,800 m in altitude, while the station is at 2,450m of altitude. Additional three stations are found around the project area at 20, 28, and 34 km apart from the head work of the project. Recently, one station was established by Tokyo University for Agriculture (TUA) at 6 km apart from the head work. The observation, particularly rain fall, of the newly established station and FAO retrieved data for important months of spate irrigation (June, July, and August) ensured adequate, relevant, and reliable data (Fig. 7).

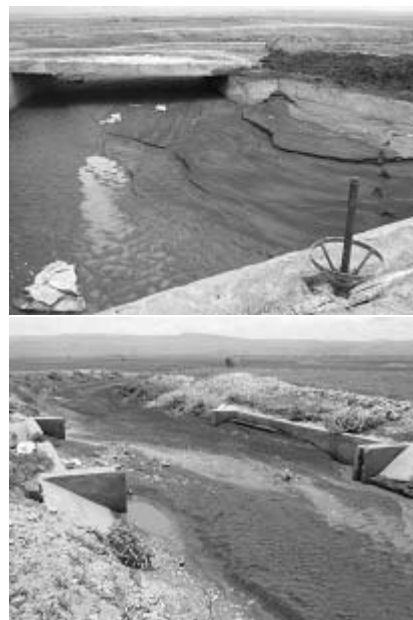
Fig. 6. Soil sedimentation in main canal (above) and division box (below).
